March 9, 2006

Subject: Creek Stability Analysis for the Hitchcock Center Redevelopment Project

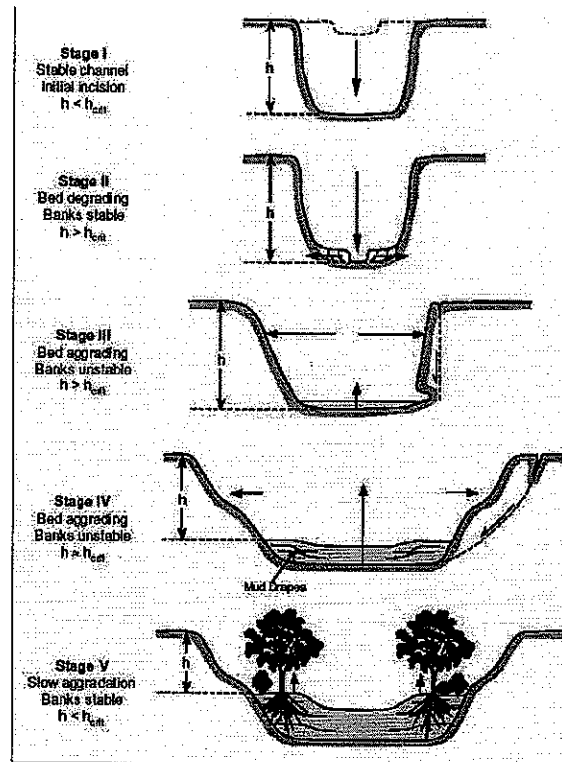
Urbanization has impacted both the creeks on site. **Figure 1** below illustrates the conceptual evaluation of the channel after channelization and urbanization. There are generally five stages of creek evolution in a degrading system (**Figure 1**). Urbanization confines creek channels, increases entrenchment and armors or stabilizes large portions of the creek banks. This has many interdependent impacts but generally it increases the entrenchment of the creeks and reduces bank erosion and sediment inputs locally. This typically leads to channel bed degradation. Typically, anthropogenic features such as culverts limit the amount of degradation potential in the urban creek systems.

Figure 1. Schematic Urban Channel Evolution

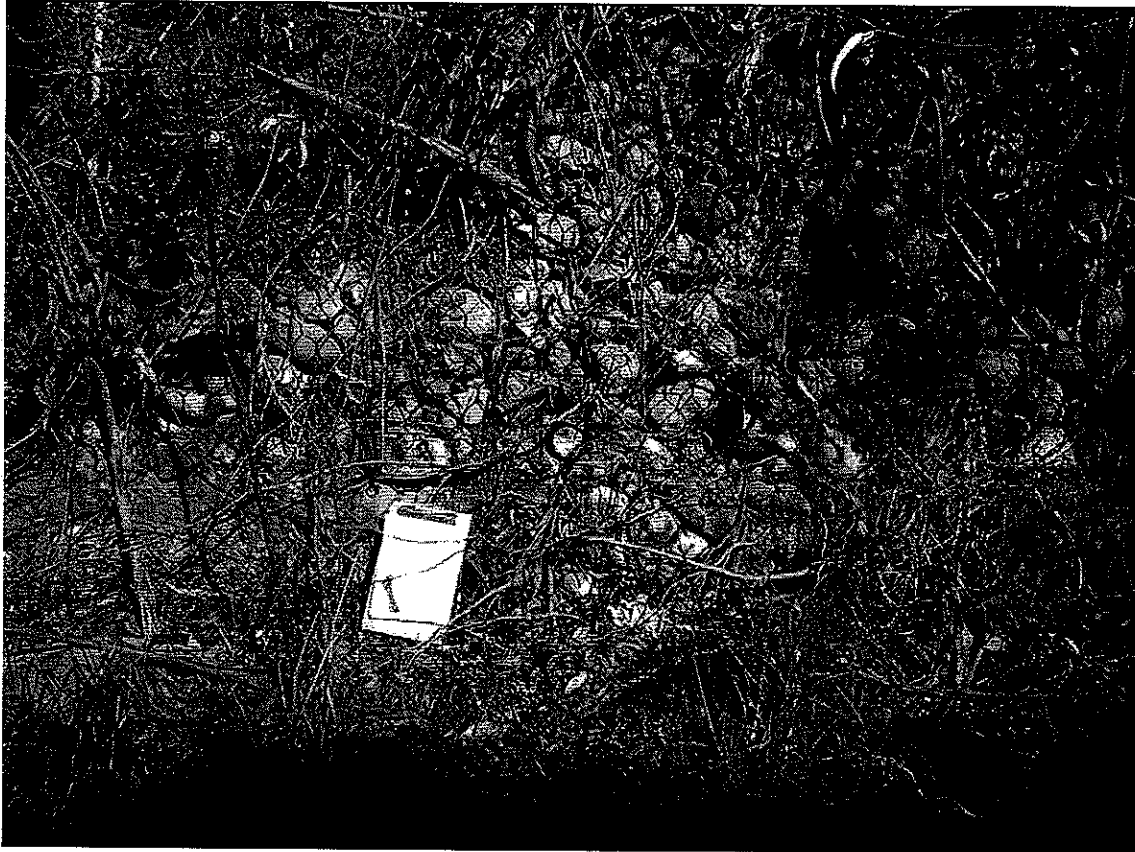
project. A small area at the base of the gabions is starting to degrade. Here the gabion basket wire has been worn away and the bottom of the basket (s) have lost their integrity. This does not appear to be a major problem but the area should be monitored to address any problems before they become large stability issues.

Photo 3. Base of gabions baskets showing broken bottoms – San Roque Creek

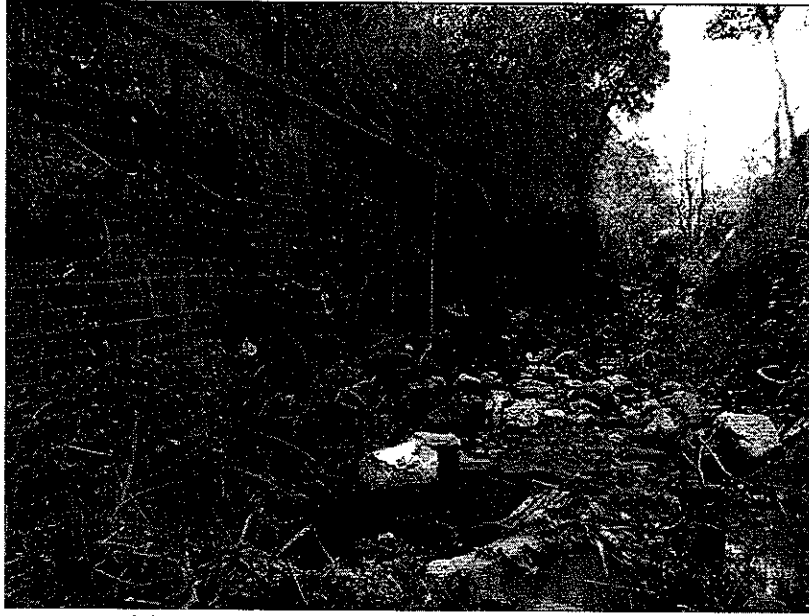
Photo 5. Degradation at the pipe and wire revetment

This erosion process will likely in time drive channel widening, potentially threatening the mature bank top oak trees and top of bank facilities. The existing pipe and wire revetment is aging and will eventually fail removing or reducing the toe support it is currently giving to the channel bank. Therefore it would not be infeasible that over time the bank top on the project site would retreat 10 feet from its present location if the bed elevation were to remain at its present location.

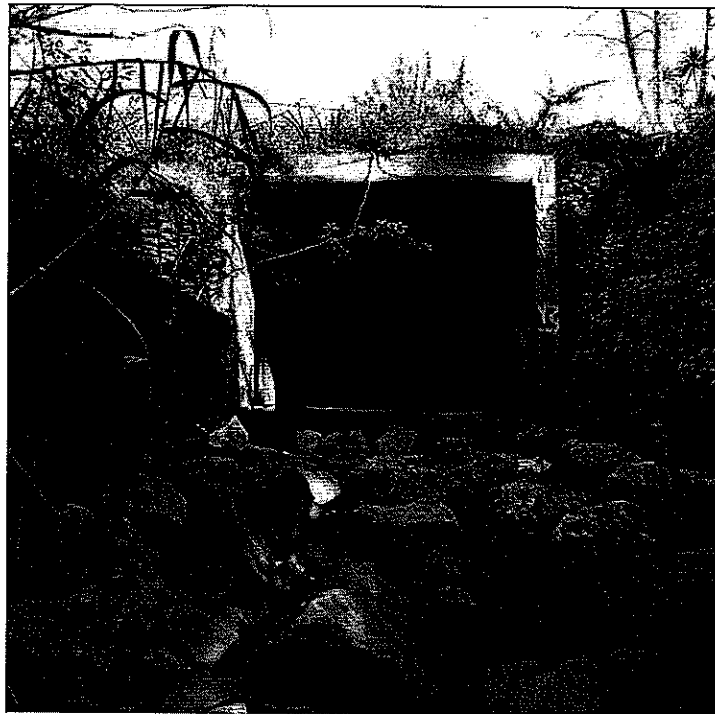
Photo 6. Boulders placed at culvert outlet to stabilize degrading bed

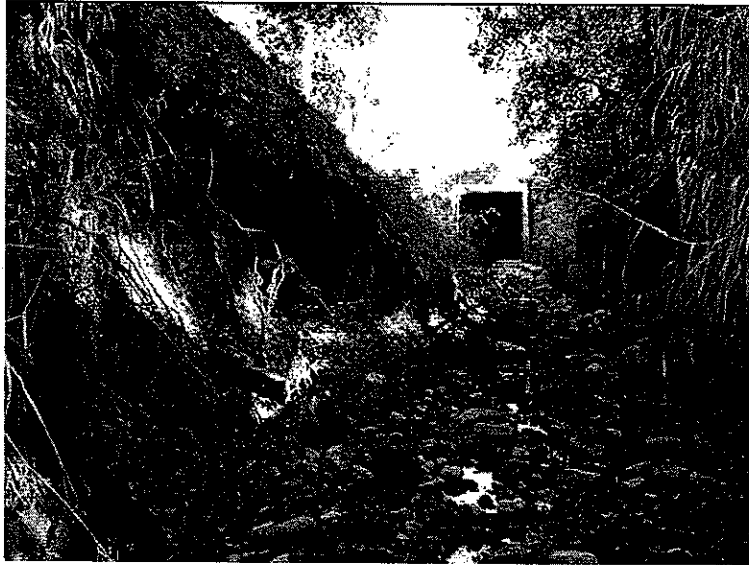
The creek banks along Arroyo Burro Creek appear to be steep and stable in the short term. At present slopes are on average 1(H): 1(V). A typical natural semi-stable slope would be in the 1.5 (H): 1(V). As the channel continues to degrade the natural tendency for the channel is to widen its top of banks through slumps and geotechnical failures. **Photo 7** shows one of these failures occurring opposite the project site.

Photo 7. Bank failures in Arroyo Burro Creek, looking towards State Street

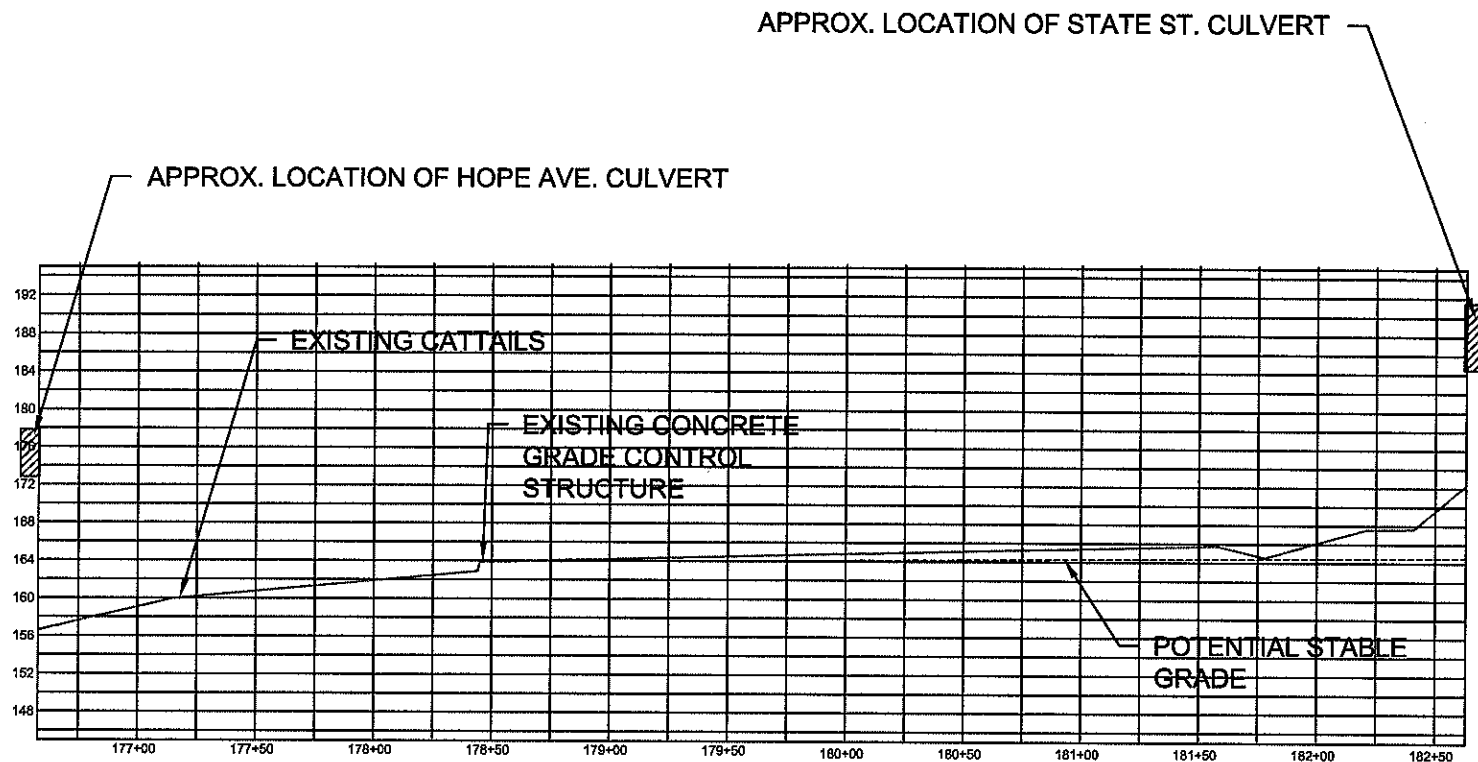
**ARROYO BURRO CREEK
 STREAMBED PROFILE ANALYSIS
 HITCHCOCK CENTER
 SANTA BARBARA, CALIFORNIA**

The project site creek reaches are bounded by culverts at Hope Street, Hitchcock Way and State Street. **Figures 2** and **3** show the profiles of both creeks. Generally, I believe that both Arroyo Burro Creek and San Roque are in creek evolutionary stages III and IV respectively. We have addressed each channel individually.

Because the bed material in Arroyo Burro Creek is predominantly sand for much of the project reach (300 feet out of 500 feet), we can roughly assume a stable long-term slope of the channel would be in the 0.3 to 0.5 percent range. The current slope between the Hope Street culvert and State Street is approximately 2.46 percent. Figures 2 and 3 show what could be the potentially stable slope given data that we have and one representative cross section. It appears that channel will continue to degrade between 6 inches to 3.5 feet over the long term if the bed load composition remains the same. The largest amount of degradation is likely to be seen immediately below the State Street culvert outlet. There is strong evidence that this has occurred and/or is currently occurring in the system. The perching of the State Street culvert and the current placement of boulder revetment at the outlet are evidence of recent channel degradation. The photos below show signs of recent degradation in the channel.
